| <b>EASA</b> | <b>AIRWORTHINESS DIRECTIVE</b> | |
| | <b>AD No.: 2014-0015</b> | |
| <b>ATA 27</b> | <b>Flight Controls – Airbrake Control Torque Tube – Inspection / Replacement</b> | |

**BE-062/SZD-50-3/2013 „PUCHACZ”**

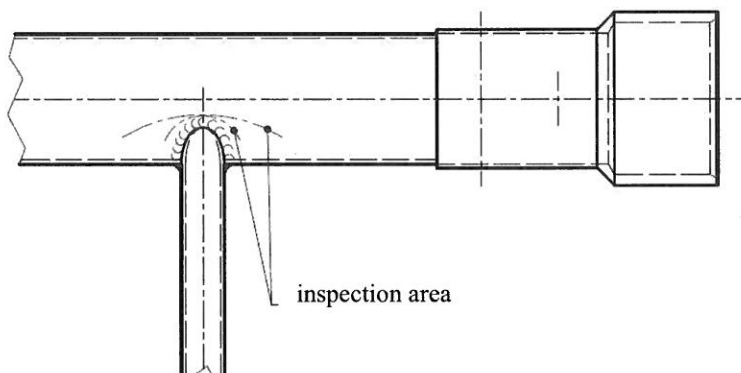
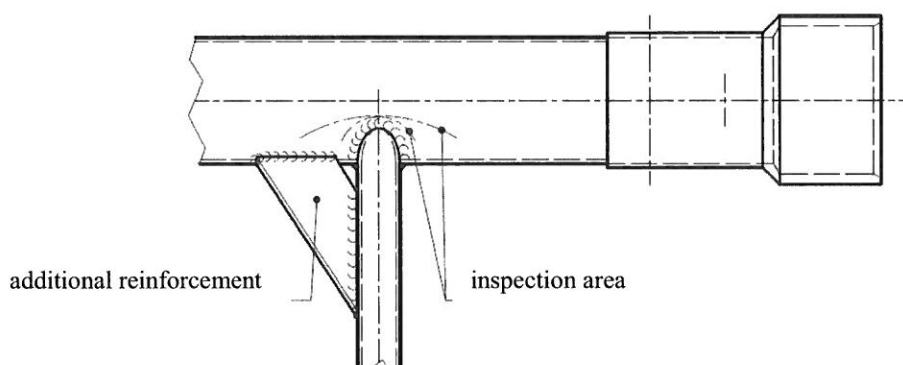
*Sketch 1 – Previous version of airbrake torque tube:  
a) without reinforcement; b) with a single reinforcement*

Up to 2003, during the flights, while operating the airbrakes, a few incidents of the torque-tube break-off from the lever located in fuselage, had been experienced. The damages occurred at the welded joint between the tube and the lever, which did not allow to retract the airbrake.

Possible reason could be a fatigue in the area of frequent occurrence of striking load, exceeding recurrently the established value or/and corrosion detected inside the area of opened tube.

- for the gliders still equipped with the old version of torque tube, with or without reinforced corner, do as follows (see Sketch 1):
  - annually or during „100-hrs” inspection, in case of whichever occurs first, inspect the welded joint of airbrake torque tube, acc. to the description specified in item 2(b) of this SB;

1. Cracks, permanent distortion of torque tube as well as corrosion pit on tube's inner side in the area of welded joint are not acceptable. In case of one of the defects listed above – replace the tube with the new one, purchased from Allstar PZL Glider – item no. 503.64.30.00A. The old tube may be released into service if no one of described defects exists.
2. Slight, uniform corrosive deposit should be removed with fine abrasive sand paper (grid 600 at min). If no corrosive pits are present on the surface, prevent inner area of the tube with anticorrosive agent (for ex. Fluidol) and release the tube into service. However, replacement the tube with the new one could be recommended.

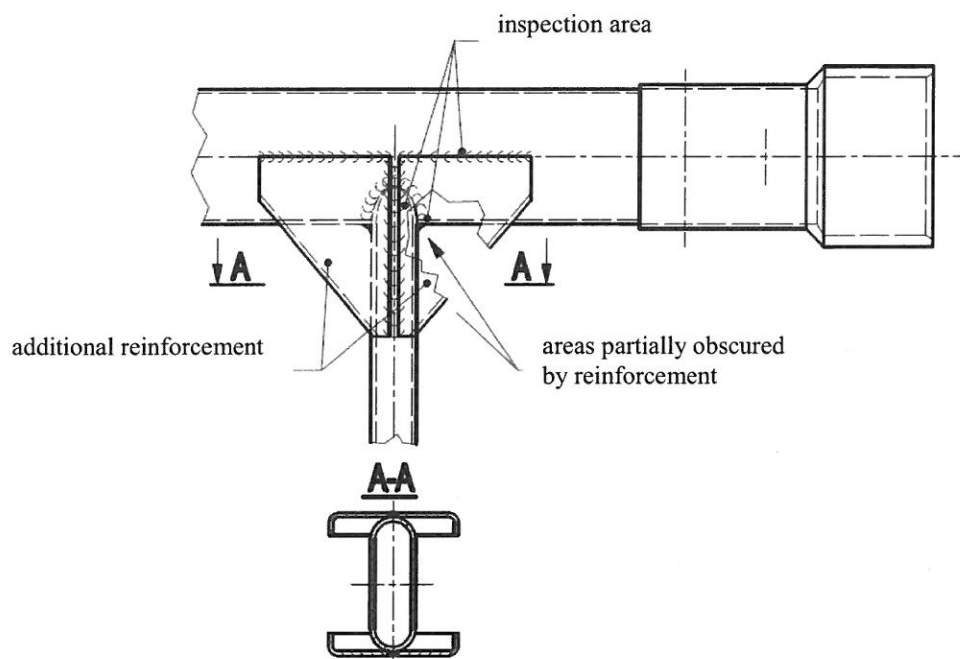
*Sketch 2 – New version of reinforced torque tube*

- for the gliders with the new type of torque tube with reinforced corners (see Sketch 2), i.e. the gliders from S/N 503.A.03.001 and up as well as others with the new type torque tube (see Sketch 2) do as follows:

- annually or during „100-hrs” inspection, whichever occurs first, check visually (disassembling of the tube from the fuselage is not necessary) the welded joint of the torque tube. Inspection of the areas partially obscured by the reinforcing plates is not required.

- during „1000-hrs” inspection check the welded joint of torque tube as described in 2(b) of this SB.

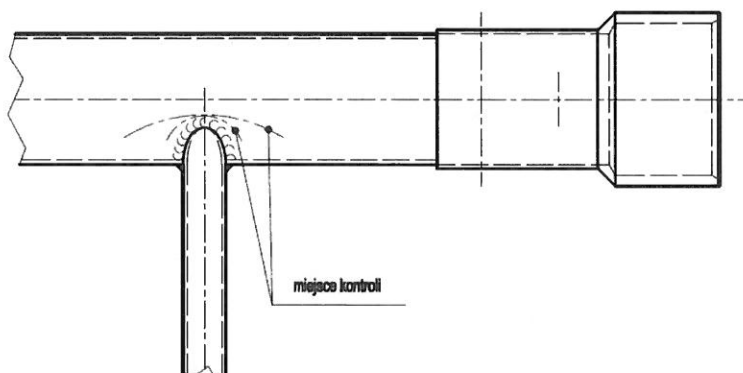
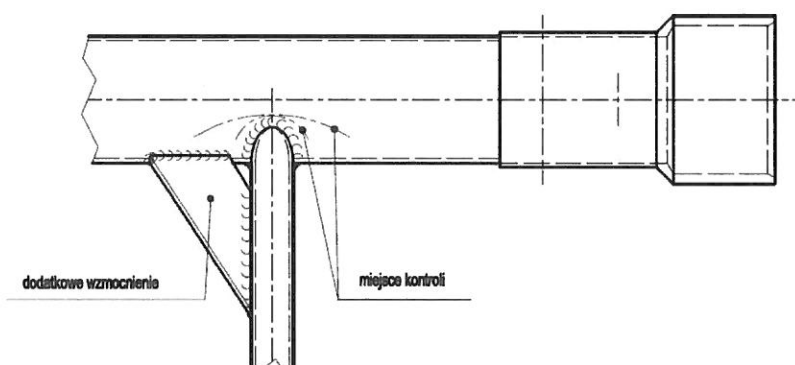
Rys. 1 - Rury skrętne starego typu: a) bez wzmocnienia; b) z pojedynczym wzmocnieniem

Podczas lotów szybowców, w czasie operowania hamulcami aerodynamicznymi, zarejestrowano do 2003 r. kilka przypadków odrywania się mieszczącej się w kadłubie dźwigni od rury skrętnej, w miejscu łączenia ich ze sobą spawaniem. Uniemożliwiało to zamknięcie hamulców podczas lotu.

Przyczyną odrywania się mogło być zmęczenie materiału w miejscu częstego uderzeniowego obciążenia, mogącego niejednokrotnie przekraczać ustaloną przepisami wartość. Przyczyną mogła być także, stwierdzona w jednym przypadku, korozja wewnątrz otwartej rury.

- dla szybowców nadal wyposażonych w rurę skrętną starego typu z dodatkowym wzmocnieniem naroża lub bez (patrz Rys. 1), należy:
  - wykonywać kontrolę połączenia spawanego dźwigni do rury skrętnej napędu hamulców, zgodnie z opisem w pkt 2(b), podczas każdego przeglądu rocznego lub „100-godzinnego”, w zależności co wystąpi pierwsze;

1. Pęknięcia, trwałe odkształcenia rury skrzywniej, jak również wżery korozyjne od wewnętrznej strony rury w okolicy spoiny są niedopuszczalne. Jeżeli którekolwiek z ww. uszkodzeń występuje – rurę skrzywną należy wymienić na nową, zakupioną w Allstar PZL Glider – element 503.64.30.00A. Rurę można użytkować dalej, o ile nie występuje żadne z ww. uszkodzeń.
2. Niewielki równomierny nalot korozyjny należy usunąć drobnym papierem ściernym (o ziarnistości min. 600). Jeżeli powierzchnia nie posiada wżerów, rurę – po zabezpieczeniu wnętrza środkiem antykorozyjnym (np. fluidolem) – można eksploatować dalej. Zaleca się jednak wymianę rury na nową.

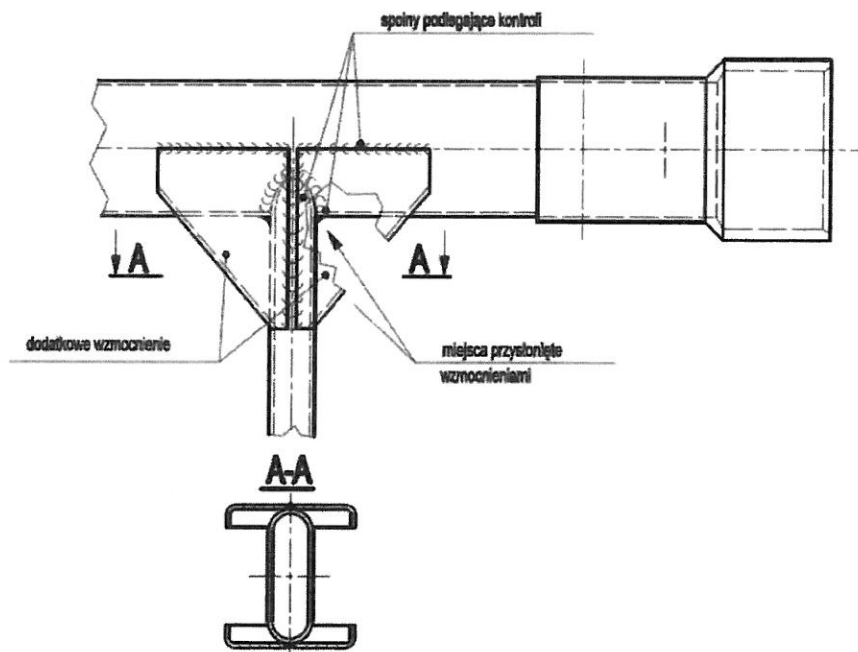
Rys. 2 - Rura skrzywna nowego typu, wzmocniona

- dla szybowców, na których zabudowano rurę skrętną nowego typu ze wzmocnionymi narożami dźwignia-rura (jak na Rys. 2), tzn. szybowców o numerach fabrycznych od S/N 503.A.03.001 wzwyż oraz wyprodukowanych wcześniej, na których wymieniono rurę na rurę nowego typu (patrz Rys. 2), należy:

- wykonywać kontrolę wzrokową (bez konieczności demontażu rury z kadłuba) połączenia spawanego dźwigni do rury skrętnej napędu hamulców podczas przeglądu rocznego lub „100-godzinnego”, w zależności co wystąpi pierwsze. Nie jest wymagana kontrola miejsc przysłoniętych wzmocnieniami.

- wykonywać kontrolę połączenia spawanego dźwigni do rury skrętnej napędu hamulców, zgodnie z opisem w pkt 2(b) podczas każdego przeglądu „1000-godzinnego”.
