**DYREKTYWA ZDATNOŚCI - AIRWORTHINESS DIRECTIVE**  
**Nr SP -0059 -2000 -A**

**1. Przedmiot:** Szybowce / gliders, model: SZD-50-3 „PUCHACZ”

### BIULETYN OBOWIĄZKOWY Nr BE-048/SZD-50-3/2000 „PUCHACZ”

### MANDATORY BULLETIN No BE-048/SZD-50-3/2000 „PUCHACZ”

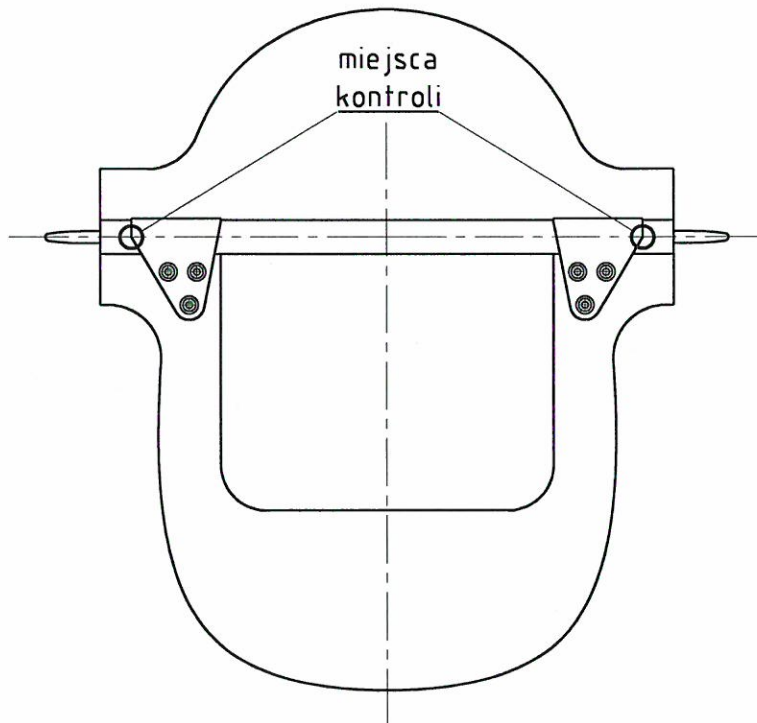
Widok  
na wręgę przednią

Biuletyn wydano ze względu na pierwsze informacje o wykryciu pęknięć konsoli przedniego zawieszenia kadłuba mocowanego do wręgi przedniej.

Kontrolę należy przeprowadzić w miejscach pokazanych na poniższym rysunku na przedniej i tylnej powierzchni wręgi przedniej.

1. Przygotowanie do kontroli miejsc wskazanych na rysunku.
  - Zmyć farbę z powierzchni i odtłuścić acetonem
  - Usunąć zanieczyszczenia z powierzchni konsoli za pomocą szczotki drucianej.
  - Wstępnie sprawdzić wytypowane miejsce przy pomocy lupy o powiększeniu przynajmniej x5.
2. W przypadku wątpliwości dla wykrycia pęknięć zastosować nieniszcząca metodę magnetyczno - fluorescencyjną, penetracyjno -fluorescencyjną lub penetracyjno - barwną zaakceptowaną przez Nadzór Lotniczy.

W przypadku wykrycia na konsoli pęknięć większych niż 3 mm należy wycofać ten egzemplarz z eksploatacji i przesłać faksem do producenta ( nr +48 33 812 37 39) następujące informacje:

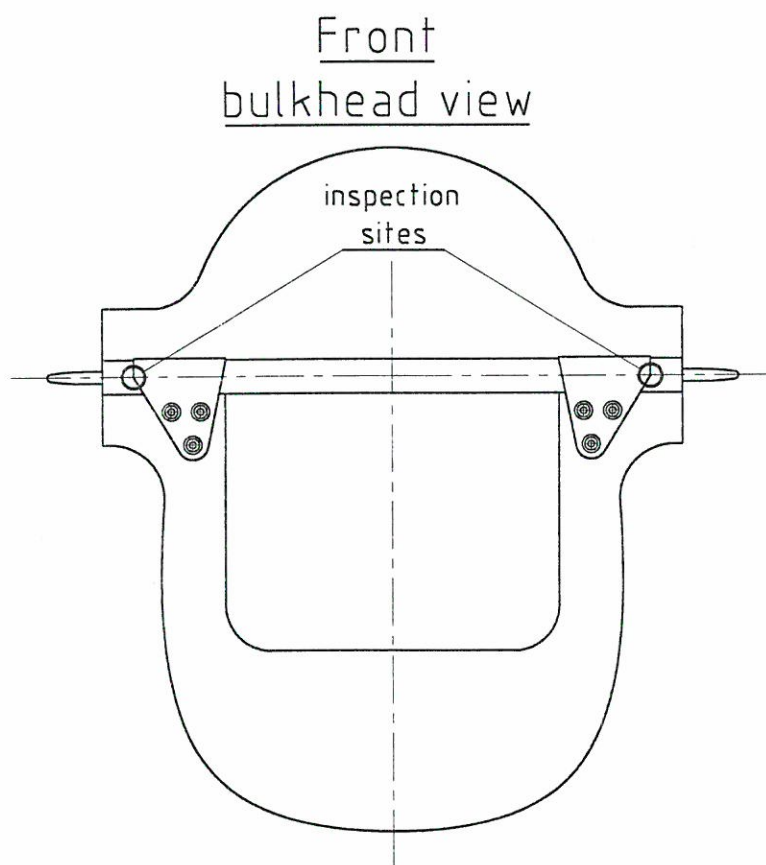
Bulletin issued due to first information on cracks detected in the front bracket console, mounted on front bulkhead fuselage.

Inspection to be held at sites indicated in the following sketch, both on front and back side of fuselage front bulkhead.

1. Preparatory action at sites specified in a sketch.
  - Wash-out paint from the surface, and de-grease the latter with acetone
  - Remove impurity from console surface with wire brush.
  - Pre-check the specified sites with aid of magnifying glass of 5x magnification, at least.
2. In case of doubts, employ the non-destructive magnetic-flourescent, penetrant-fluorescent or penetrant-colour method accepted by Airworthiness Authority.

| <p><b><u>4. FINAL CONCLUSIONS</u></b></p> <p>In case of finding on a console cracks above 3 mm, this plane should be withdrawn from operation, and producer is to be supplied by fax (No +48 33 812 37 39) with the following information:</p> <ul style="list-style-type: none"> <li>- glider Factory No,</li> <li>- year of production</li> <li>- total flying time</li> <li>- total amount of hour flown in aerobatics</li> <li>- location and size of detected crack,</li> </ul> <p>After collecting the necessary information, a Bulletin will be issued - one specifying the repair procedure.</p> <p><b><u>5. ENCLOSURES</u></b></p> <p>There are no enclosures to this Bulletin.</p> <p style="text-align: center;">- THE END -</p> | | |
